Cases for gas turbines on offshore drilling platforms to remove varnish

Device name: GE/Solar/RUSTON gas turbine generator set

Oil purifier model: WVD-II varnish removal unit

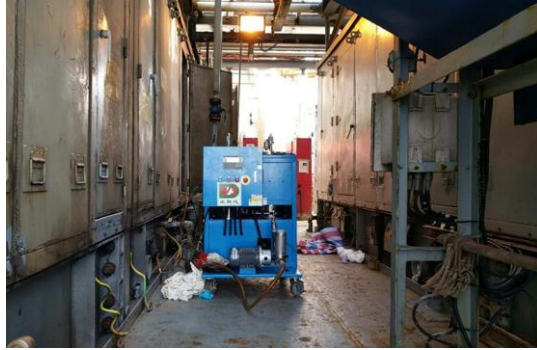
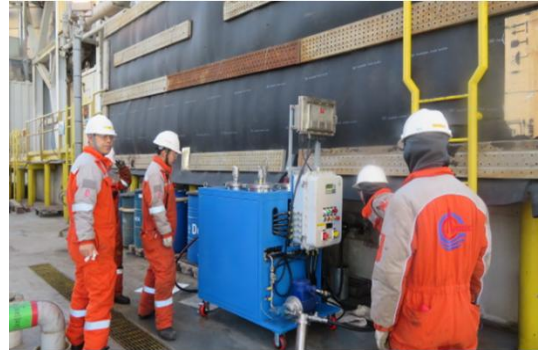
Before purification

Operating conditions of the unit: high varnish tendency index, high oil temperature and control valve due to varnish problems, resulting in unstable control pressure

After purification

Unit operation: The varnish tendency index, oil temperature and control valve pressure return to normal.

In December 2016, we selected the WVD-II varnish removal unit special for removing varnish and sludge from the company for online circulation purification. After the third-party oil samples were compared and tested before and after purification, the MPC value before purification was 31.5, and the MPC value dropped to 4.4 after purification. The content of wear metal elements in the oil also returned to normal, and the control pressure of the lubricating oil was gradually stabilized, and the effect was obvious.
