# Air Separation Application

## Industrial Gas Manufacturer Increases Maintenance Interval

## Industrial Gas Manufacturer Mitigates Varnish Potential

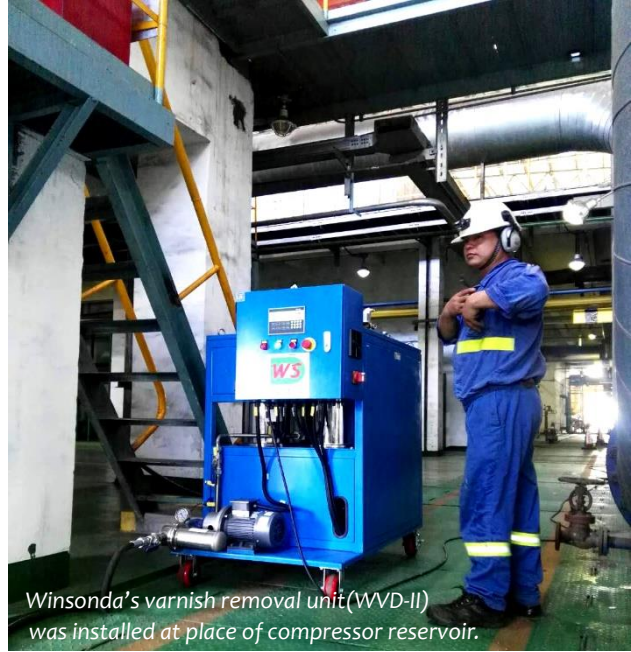
Client has the problem of overheated bearing during operation and the temperature was much close to the value that machine went to shutdown. Considering heavy production tasks, they cannot have machine stopped for an overhaul inspection and maintenance.

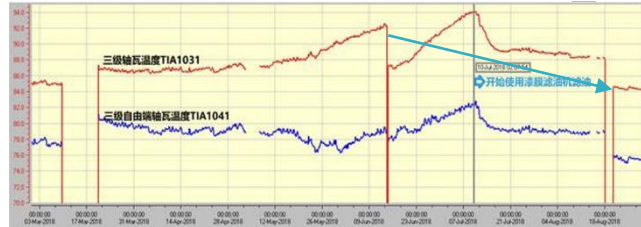
Winsonda's varnish removal unit was installed at the place of reservoir with a flow rate 1200L per hour in July 2018 which aims to remove the particles and products of oil degradation (Varnish/Sludge) in lubricating system.

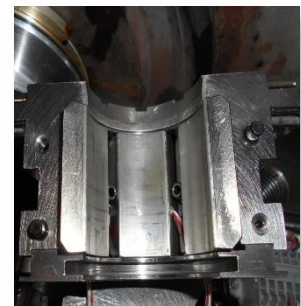
After one month continuous filtration process, client hasn't experienced the problem of overheated bearings. Also the cleanliness of lubricant improved drastically and mitigate the varnish potential with an optimal MPC value.

Date	2018/7/11	2018/8/31	2018/10/24
ISO 4406	23/22/12	18/17/12	17/15/12
MPC Value	17.7	13.3	8.6
AN	0.24	0.16	0.15

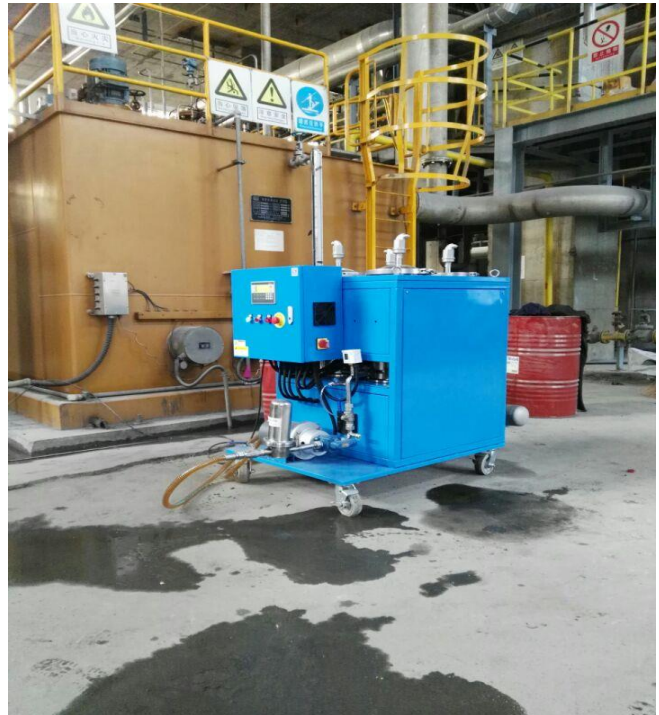
Based on cycle lube inspection, client found out the MPC value (varnish potential ) is with a rising trend and there are serious varnish formation at the bearing side.

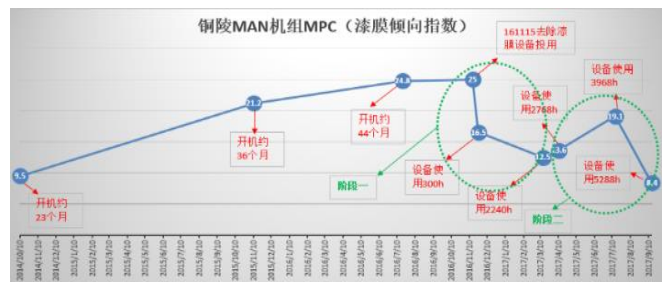
To avoid unscheduled breakdown and stop the lubricant deteriorating further Winsonda’s varnish removal unit (**WVD-II**) was recommended and installed to the reservoir with a flow rate 1200L per hour on 15<sup>th</sup>, Nov. 2016 which is designed to mitigate the varnish potential.

Date	2016/11/15	2017/3/10	2017/9/10
MPC	24.8	16.3	12.5
