Power Plant Application

SEC is a large gas-steam combined cycle power plant with a capacity of 2×180MW Locating in Shenzhen City, China.

SOLUTION

Winsonda's advance varnish removal unit (WVD-II) has been installed to the reservoir on 28th Mar. 2016 which aims to mitigate the varnish deposits and clean whole oil system.

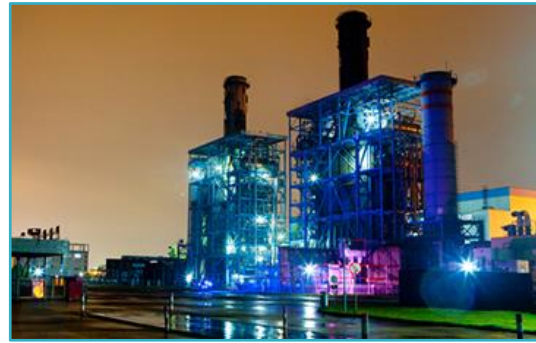
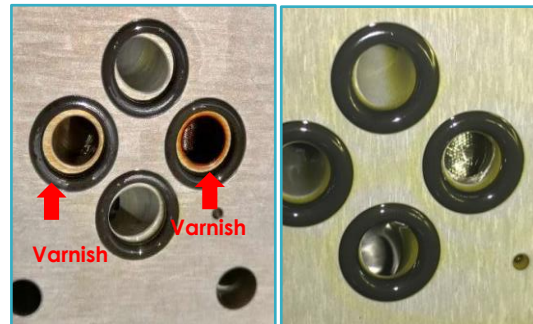
BEFORE

Customer has experienced sticky servo valve caused trips several times which brought them heavy loss from no guaranteed uptime. An oil sample was took and analysis report showed an MPC $\Delta E=43.7$ that indicated high varnish potential. The oil degradation deposits formed in oil system, shorten the lifetime of lubrication & critical components. That all pushed client to take action to prevent the occurrences of unscheduled breakdown.

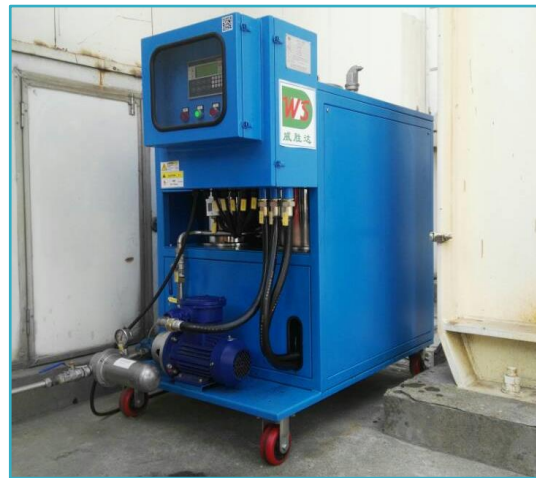
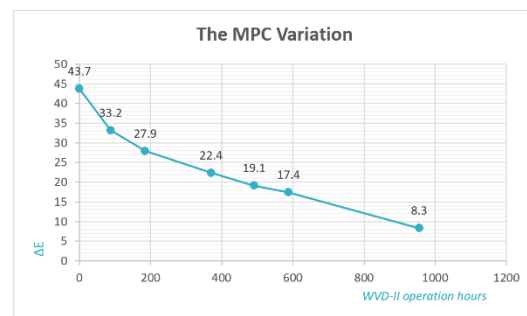
AFTER

On 1st, April, MPC value dropped to 33.2

On 18th, April, ΔE reached 19.1

On 12nd, May, ΔE reached 8.3.

The result was clear and client was great satisfied with the performance of WVD-II when they rechecked the servo valve with a clean orifices condition. Moreover, all copies of oil analysis reports showed Winsonda's varnish removal units was no harmful to relative oil additives. Client expressed their ideas to keep cooperation with us oil contamination control.
